# Shenzhen ORT Technical Services Co., Ltd.

## TEST REPORT

| Report Number<br>ORT250715112001-R02 | | | | | |
| Sample Name: | Tablet | | Applicant: | Shenzhen Huafurui Technology Co., Ltd. | |

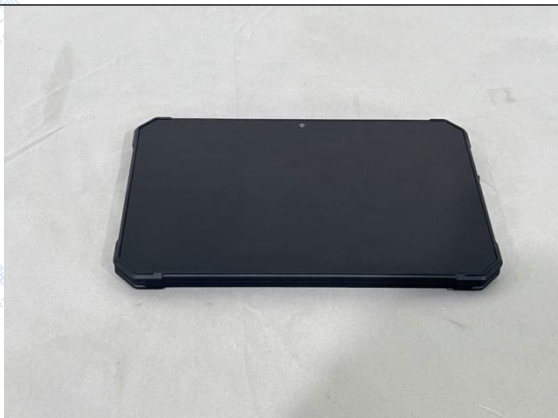
| Fig.1 Appearance inspection before test | Fig.2 Appearance inspection before test |

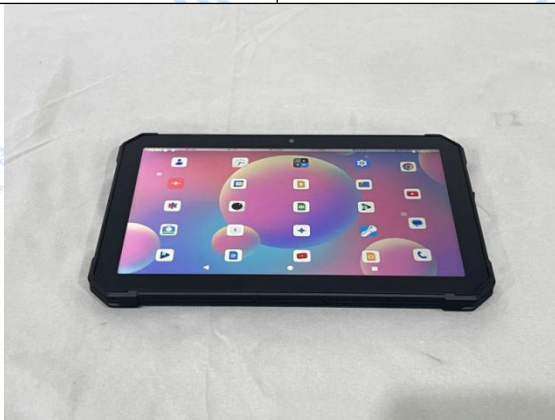
| Fig.3 Power on inspection before test | |

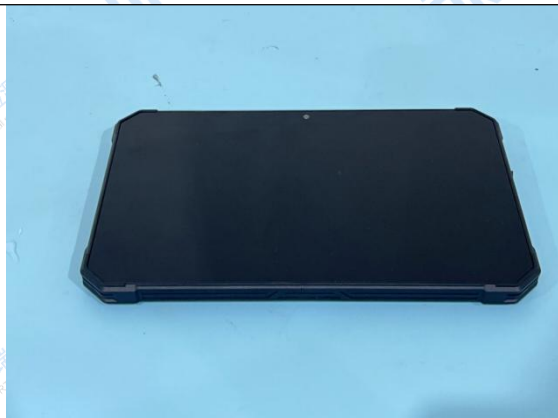
Fig.5 Appearance inspection after test

| Sample No. | Inspection after test | Conclusion |
|---|---|---|
| ORT250715112001-SS1/5 | The appearance of the sample has no visible damage, the startup function is normal, and there is no water inside. | Pass |

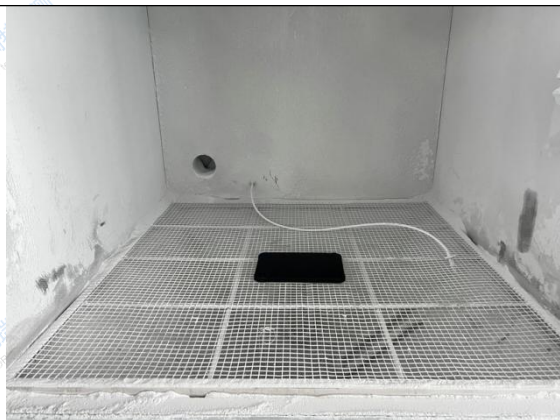
Fig.14 Test setup

Mode dust movement: Air and dust mixing exercise for 6 s, pause for 15 min

Test duration: 20 cycles

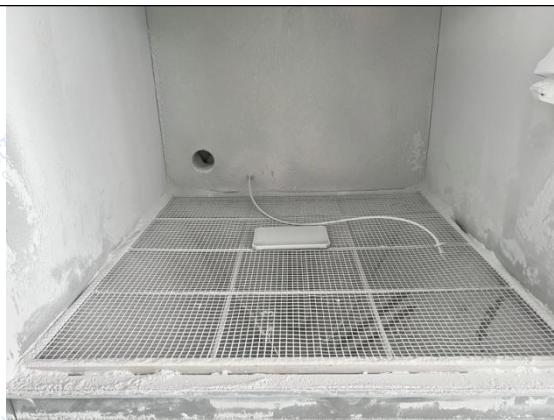
Fig.15 Test setup

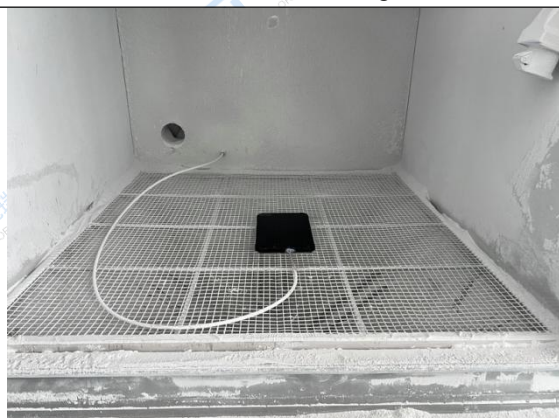
Fig.25 Test setup

2.1 During the experiment, the dosage of talc powder was  $2\text{ kg/m}^3$ , And test for 8 hours.

2.2 The enclosure under test is supported inside the test chamber and the pressure inside the enclosure is maintained below the surrounding atmospheric pressure by a vacuum pump. A volume of air 80 times the volume of the sample enclosure, the extraction rate of 40 volumes per hour, and test 2 hours.

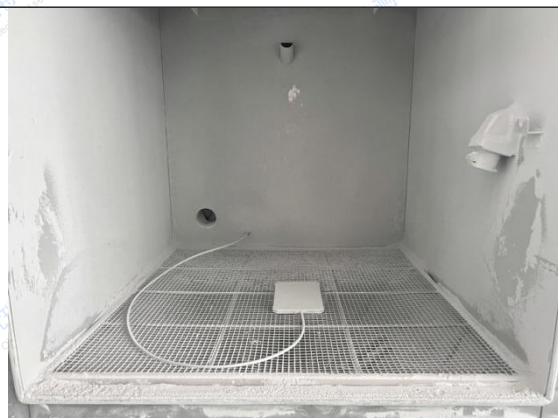
Fig.26 Test setup

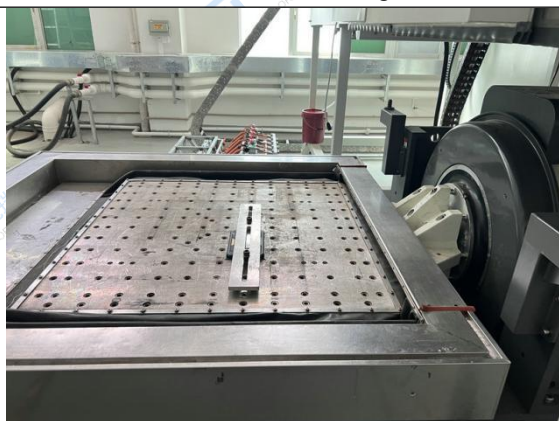
Fig.42 Test setup (X axis)

| 5~14 | / | 5.08 | X, Y, Z axis | 2 h/axis |
| 14~33 | 2 | / | | |
| 33~52 | / | 0.91 | | |
| 52~500 | 5 | / | | |

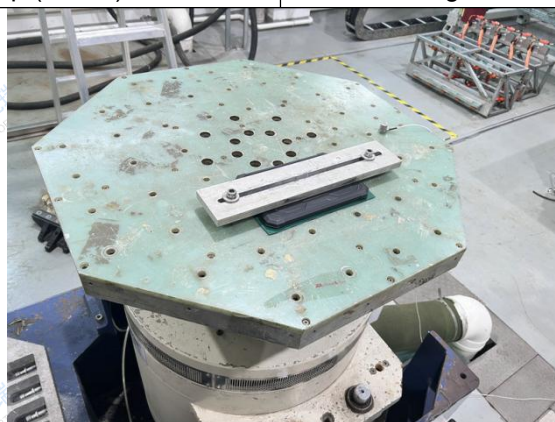
Fig.44 Test setup (Z axis)

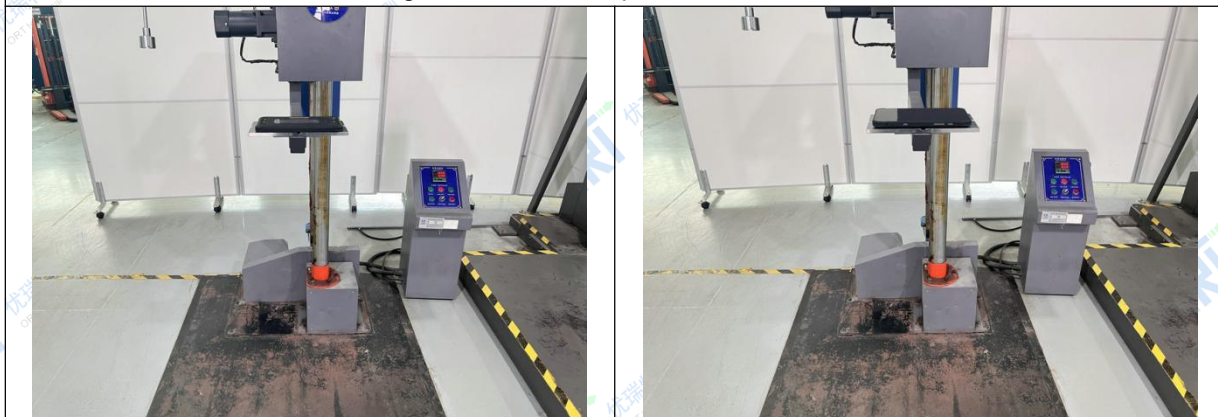
Fig.54 Test setup- Face (1)

Height of drop: 122 cm

Orientation of drop: 6 faces, 8 corners, 12 edges.

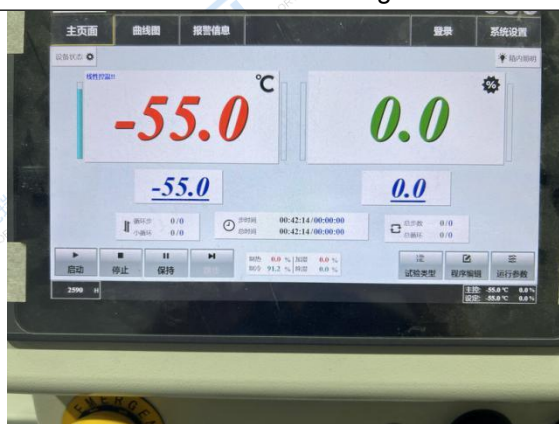
Fig.86 Temperature: -55 °C

| Shock Test Parameter | | Temperature Test Parameter |
|---|---|---|
| Pulse Shape: | Half Sine | -55℃, 70℃. |

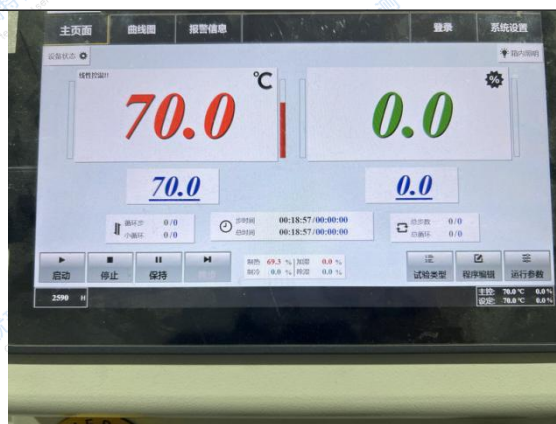
Fig.87 Temperature: 70 °C

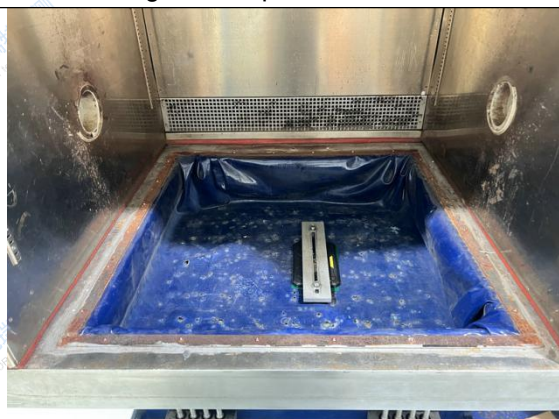
Fig.88 Test setup (X axis)
