# Shenzhen ORT Technical Services Co., Ltd.

## TEST REPORT

| Report Number<br>ORT250715112001-R01 | | | | | |
| Test Item: | 1.IPX9K Test; 2.IP6KX Test; 3.IP6X Test; 4.IPX8 Test; 5.Vibration Test; 6.Drop Test; 7.Combined Temperature and Shock Test. | | | | |

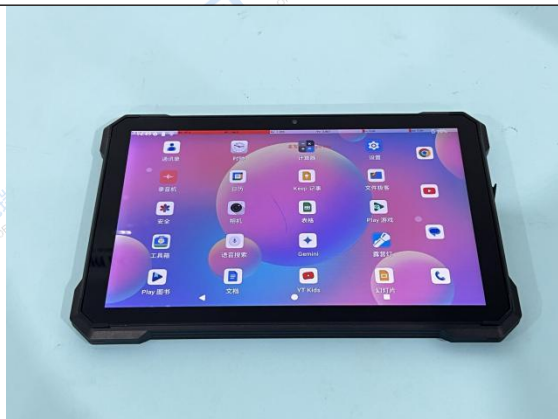
| Sample No. | Inspection after test | Conclusion |
|---|---|---|
| ORT250715112001-SS1/5 | The appearance of the sample has no visible damage, the startup function is normal, and there is no water inside. | Pass |

Fig.7 Power on inspection after test

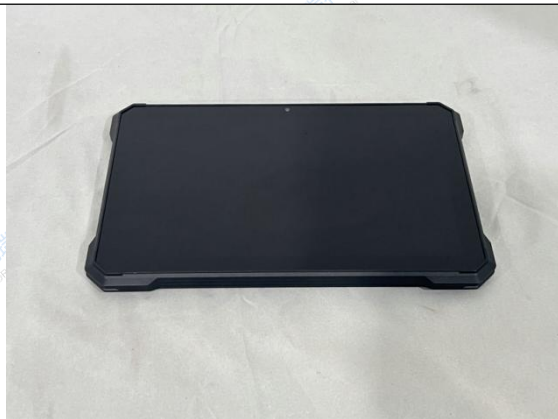
Fig.9 Appearance inspection before test

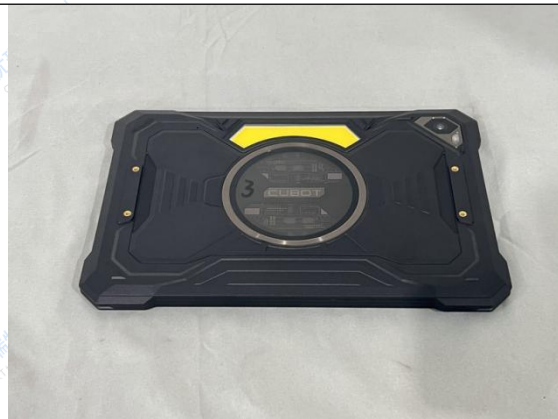
Fig.10 Appearance inspection before test

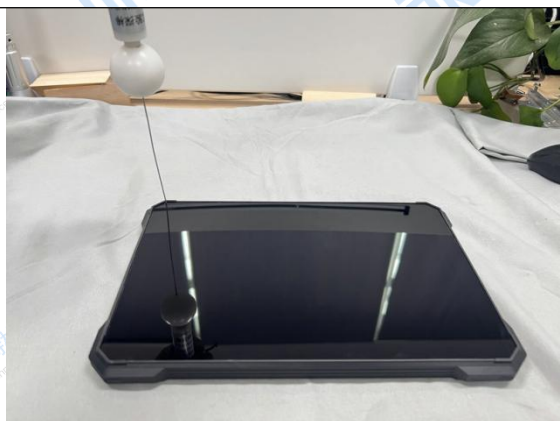
- 1) The level of protection indicated by the first characteristic for approaching hazardous components Number, first characteristic number 6 K 1.0mmΦ The test line should not be pierced and sufficient clearance should be maintained.
- 2) Protection against solid foreign objects represented by the first characteristic number and the first characteristic number 6 K.

Fig.11 Detective rod detection

Fig.12 Detective rod detection

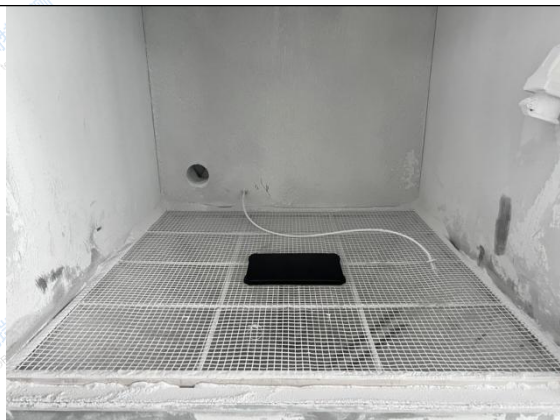
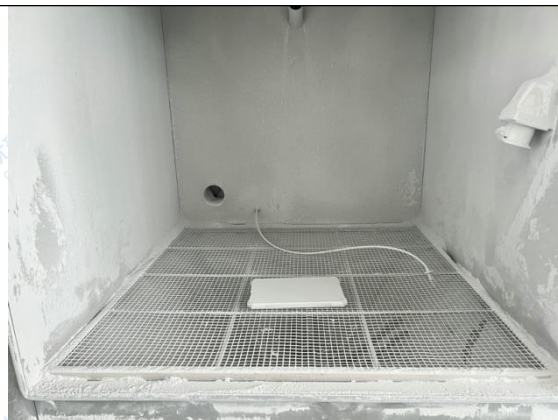
Mode dust movement: Air and dust mixing exercise for 6 s, pause for 15 min

Test duration: 20 cycles

Fig.14 Test setup

Fig.15 Test setup

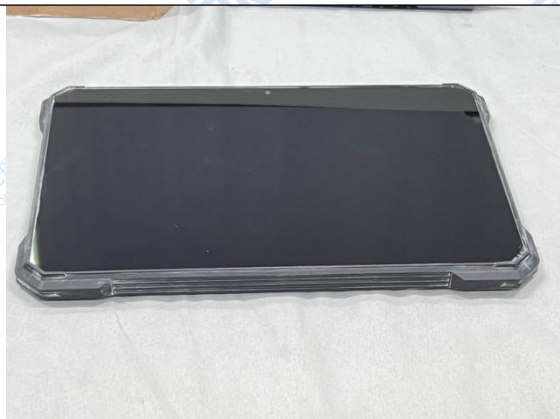
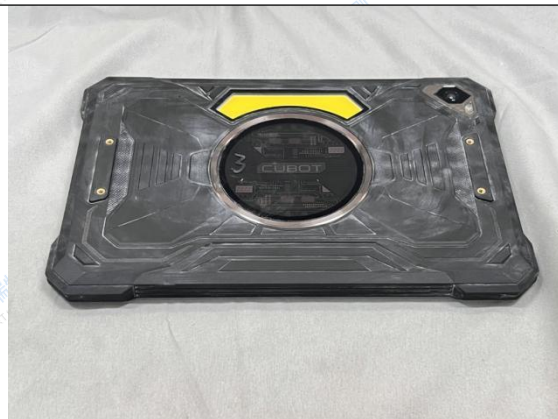
| Sample No. | Inspection after test | Conclusion |
|---|---|---|
| ORT250715112001-SS2/5 | The sample function is normal, and after the sample disassembly and inspection, there is no dust inside the sample. | Pass |

Fig.16 Appearance inspection after test

Fig.17 Appearance inspection after test

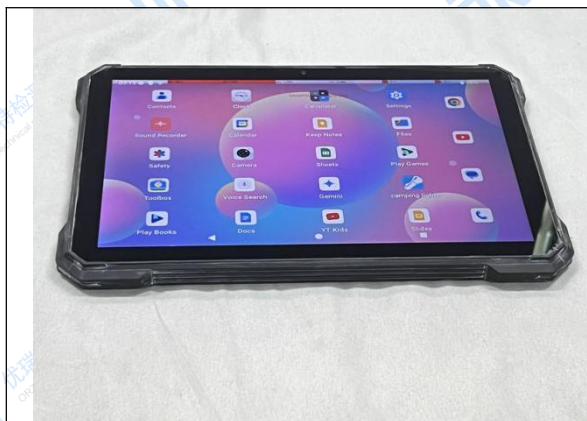
Fig.18 Power on inspection after test

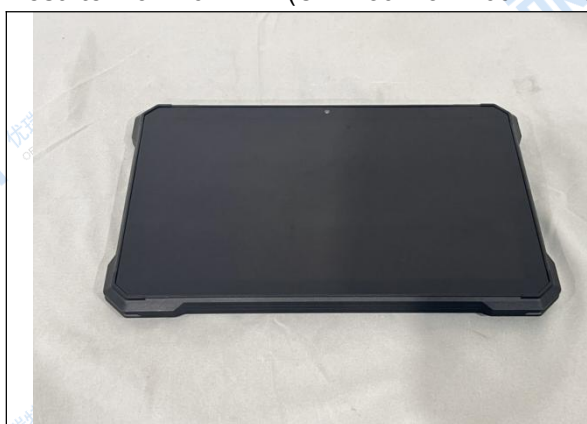
Fig.20 Appearance inspection before test

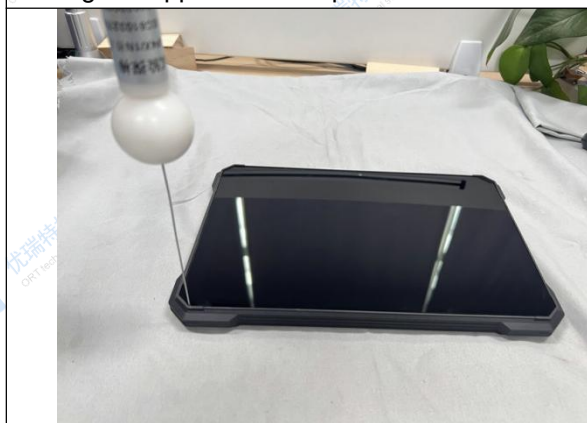
The test wire of  $\Phi 1.0\text{mm}$  shall not penetrate and adequate clearance shall be kept.

Fig.22 Detective rod detection

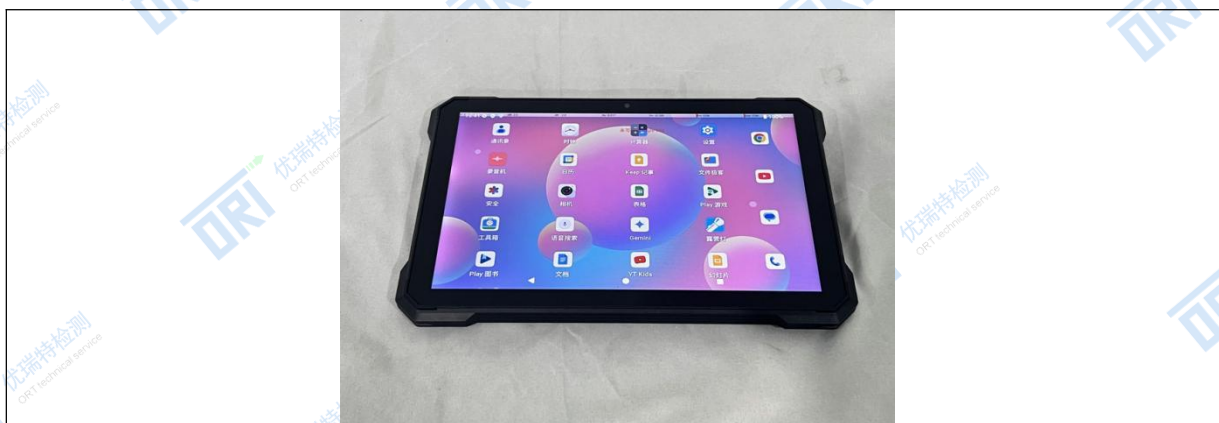
Fig.24 Power on inspection before test

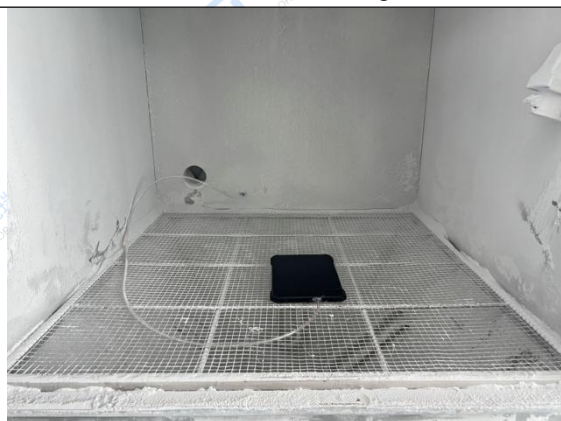
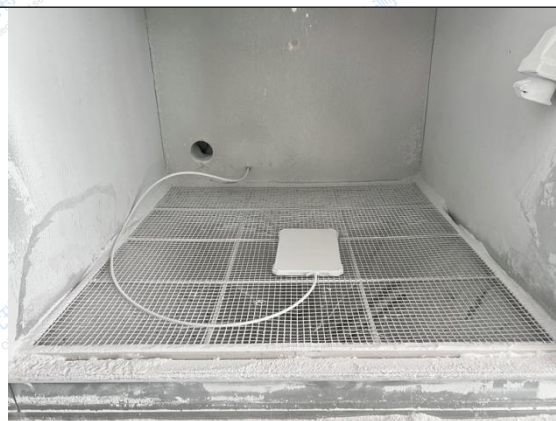
2.1 During the experiment, the dosage of talc powder was  $2\text{ kg/m}^3$ , And test for 8 hours.

2.2 The enclosure under test is supported inside the test chamber and the pressure inside the enclosure is maintained below the surrounding atmospheric pressure by a vacuum pump. A volume of air 80 times the volume of the sample enclosure, the extraction rate of 40 volumes per hour, and test 2 hours.

Fig.25 Test setup

Fig.26 Test setup

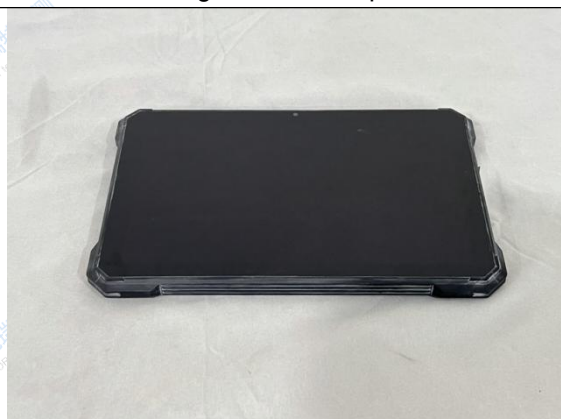
| Sample No. | Inspection after test | Conclusion |
|---|---|---|
| ORT250715112001-SS2/5 | The sample function is normal, and after the sample disassembly and inspection, there is no dust inside the sample. | Pass |

Fig.27 Appearance inspection after test

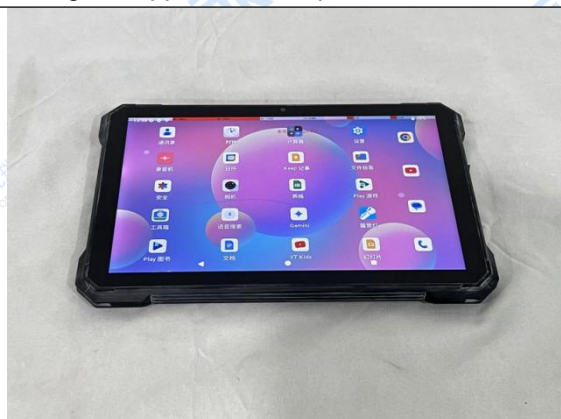
Fig.29 Power on inspection after test

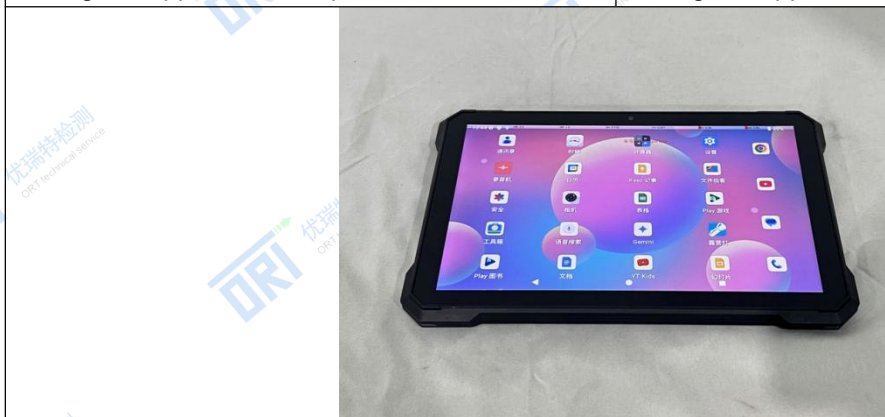
Fig.33 Power on inspection before test

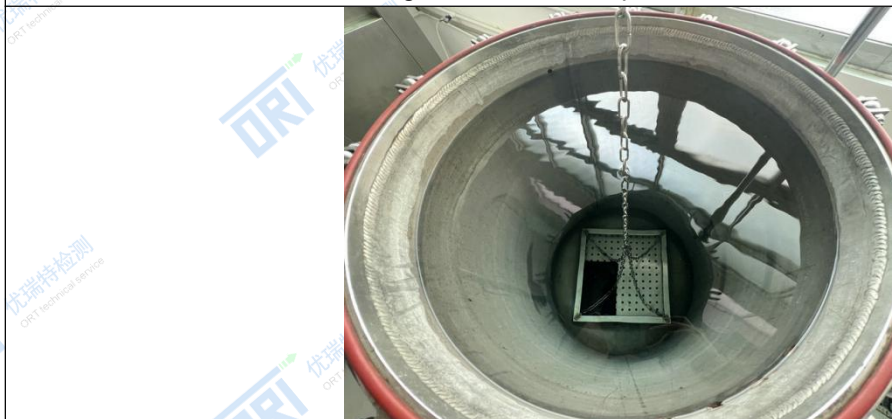
- 1) Put the sample into the test device;
- 2) Depth: 1.5 m; Test duration: 30 min;
- 3) The temperature difference between the water and the sample is no more than 5 K.

Fig.34 Test setup

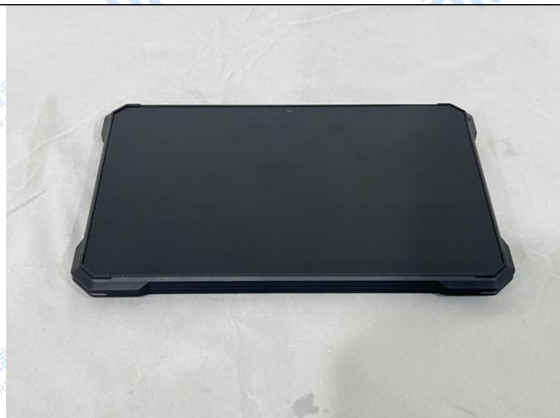
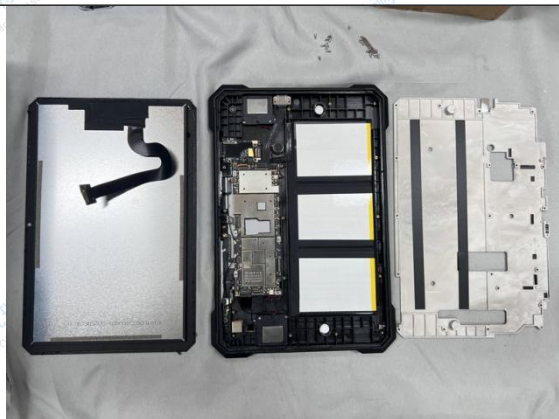
| Sample No. | Inspection after test | Conclusion |
|---|---|---|
| ORT250715112001-SS3/5 | The sample function is normal, and after the sample disassembly and inspection, there is no water inside the sample. | Pass |

Fig.35 Appearance inspection after test

Fig.38 Appearance inspection after test

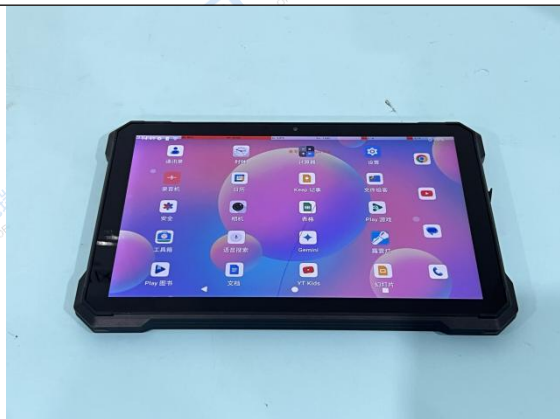
Fig.37 Power on inspection after test

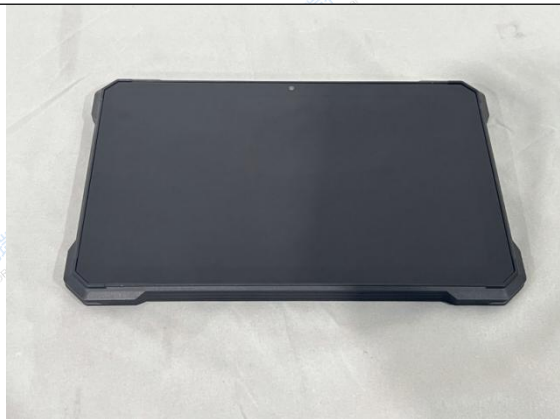
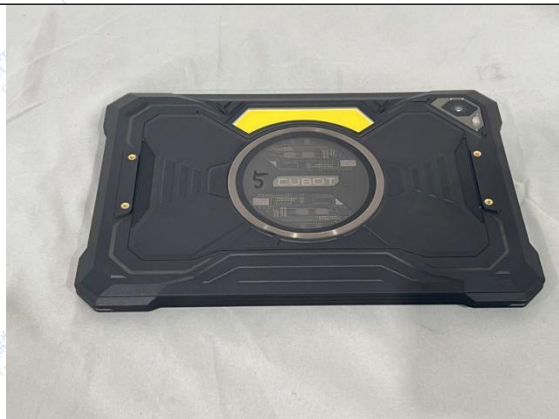
Fig.39 Appearance inspection before test

Fig.40 Appearance inspection before test

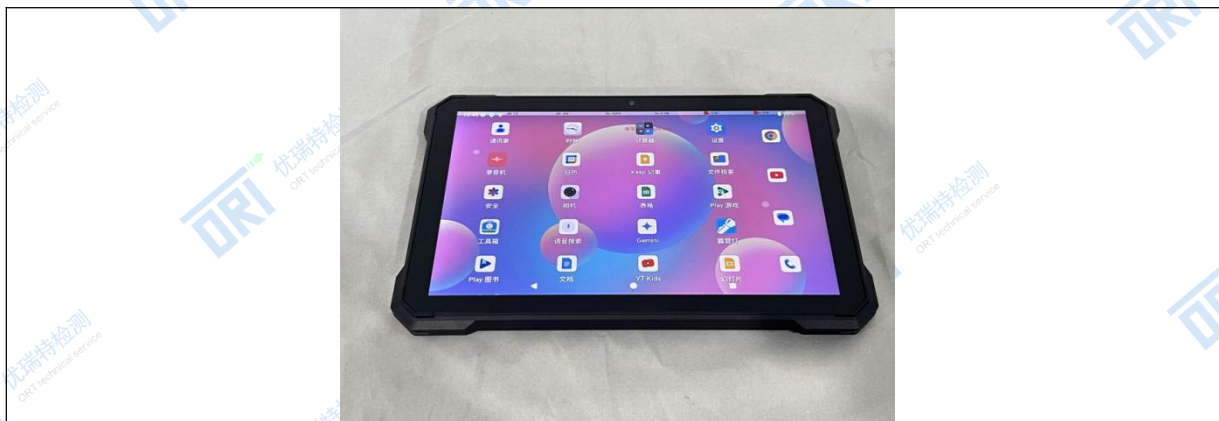
Fig.41 Power on inspection before test

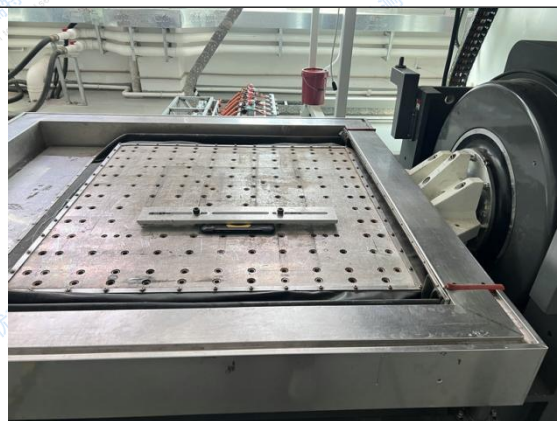
Fig.42 Test setup (X axis)

Fig.43 Test setup (Y axis)

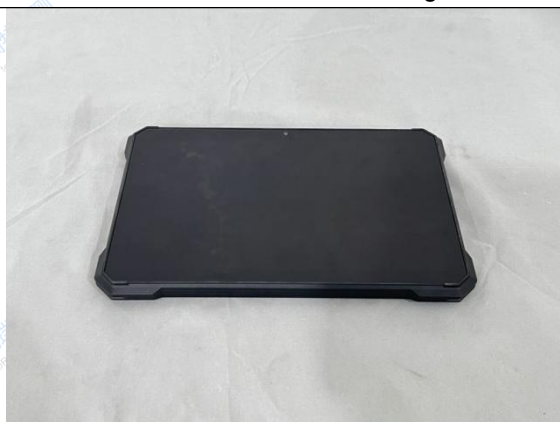
| Sample No. | Inspection after test | Conclusion |
|---|---|---|
| ORT250715112001-SS4/5 | The sample had no abnormal appearance, and the sample function was normal. | Pass |

Fig.48 Appearance inspection after test

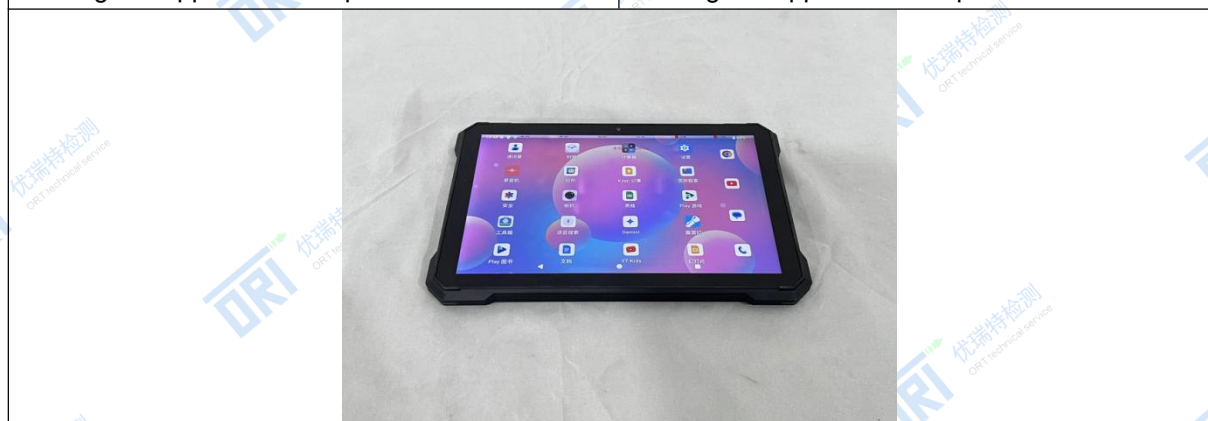
Fig.50 Power on inspection after test

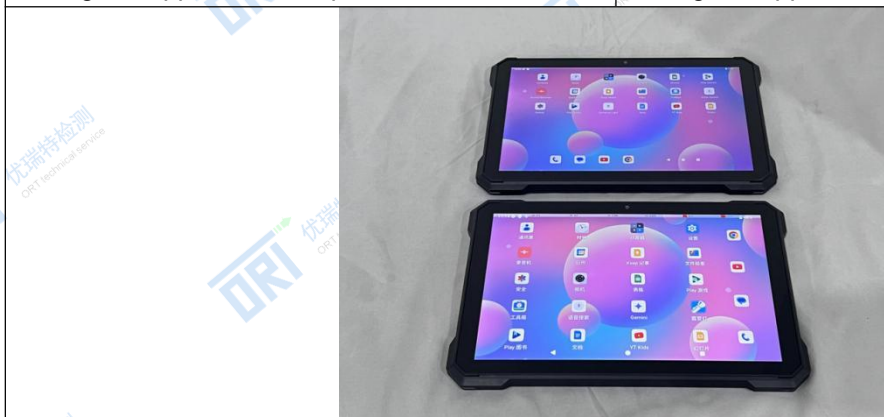
Fig.53 Power on inspection before test

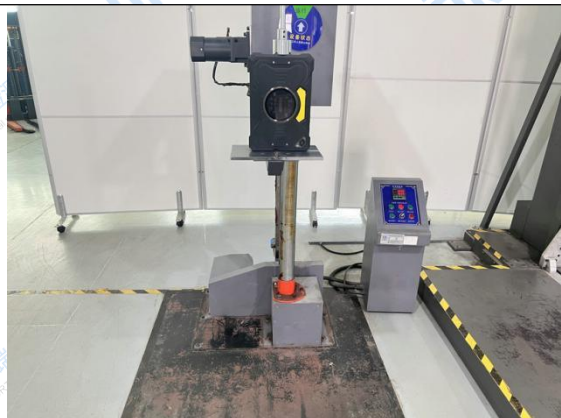
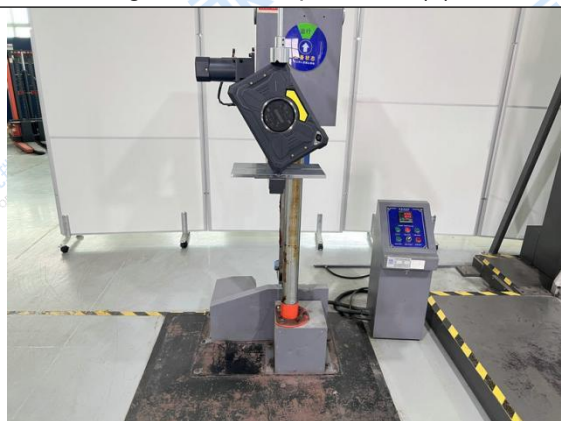
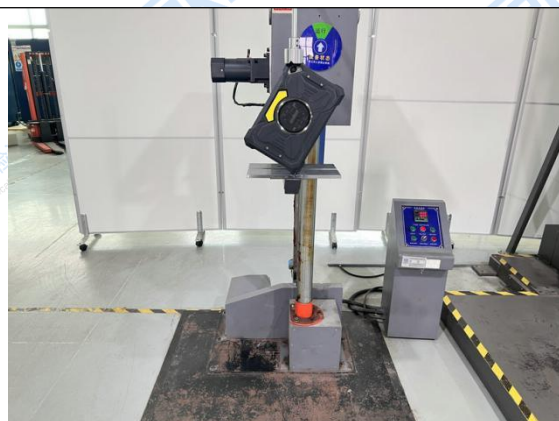
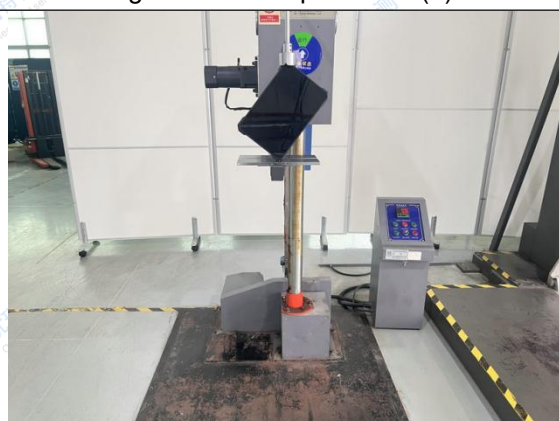
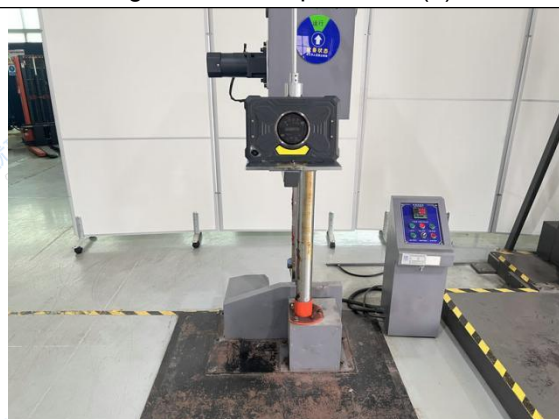
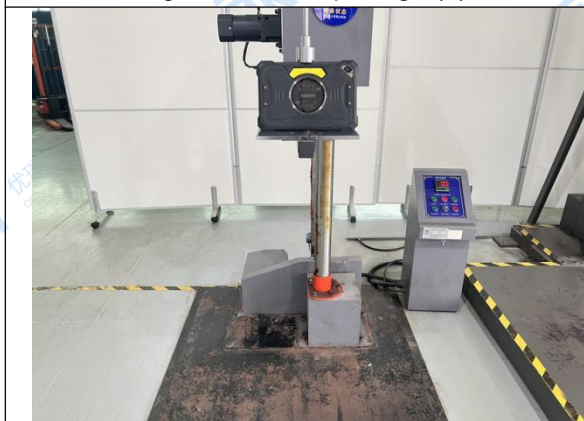
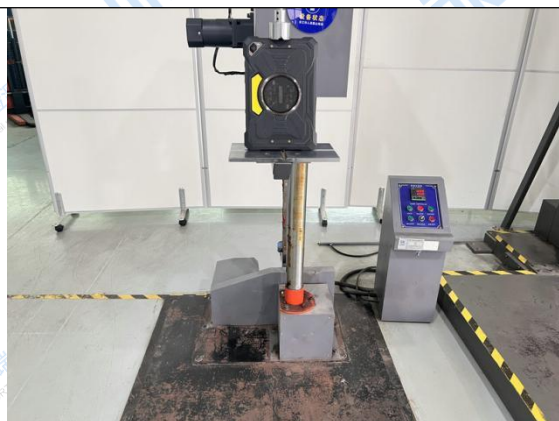
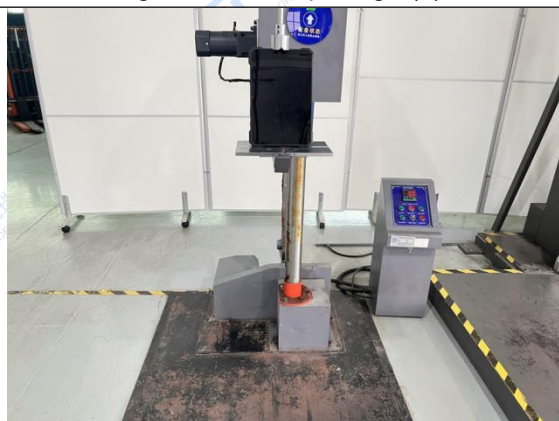
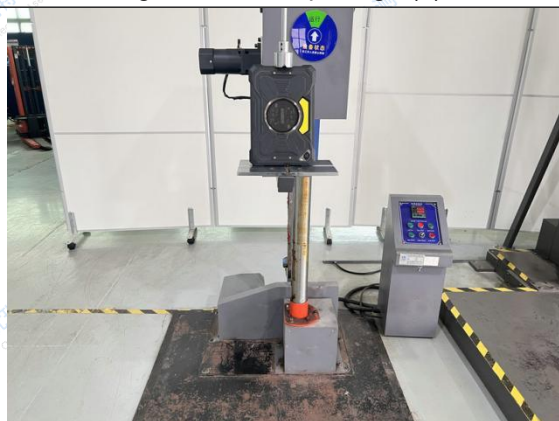
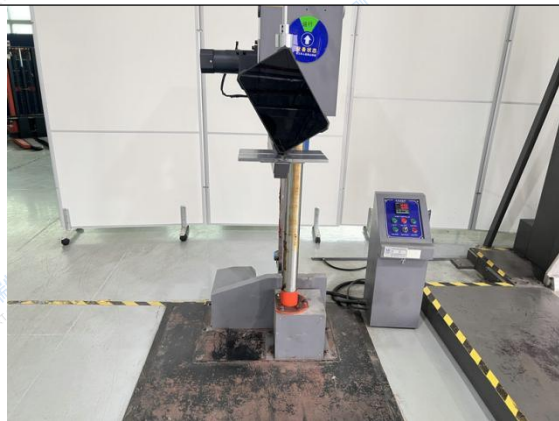
Height of drop: 122 cm

Orientation of drop: 6 faces, 8 corners, 12 edges.

Fig.54 Test setup- Face (1)

Fig.56 Test setup- Face (3)

Fig.60 Test setup- Corner (1)

Fig.68 Test setup- Edge (1)

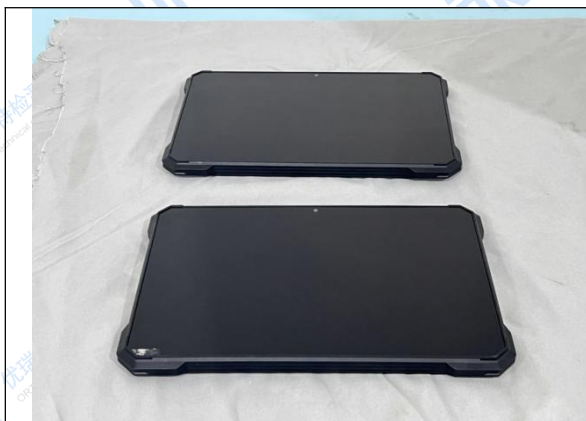
| Sample No. | Inspection after test | Conclusion |
|---|---|---|
| ORT250715112001-SS5/5 | Sample in good appearance and normal function. | Pass |

Fig.80 Appearance inspection after test

Fig.82 Power on inspection after test

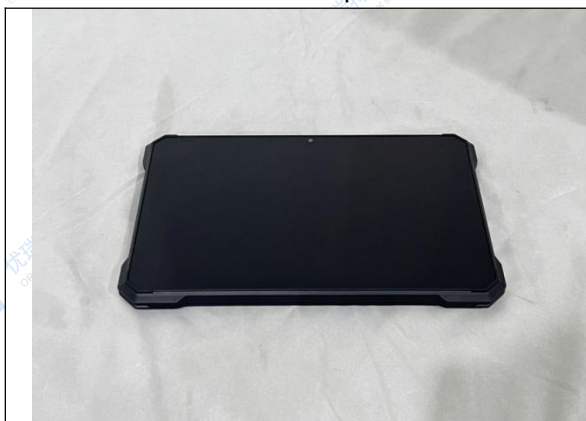
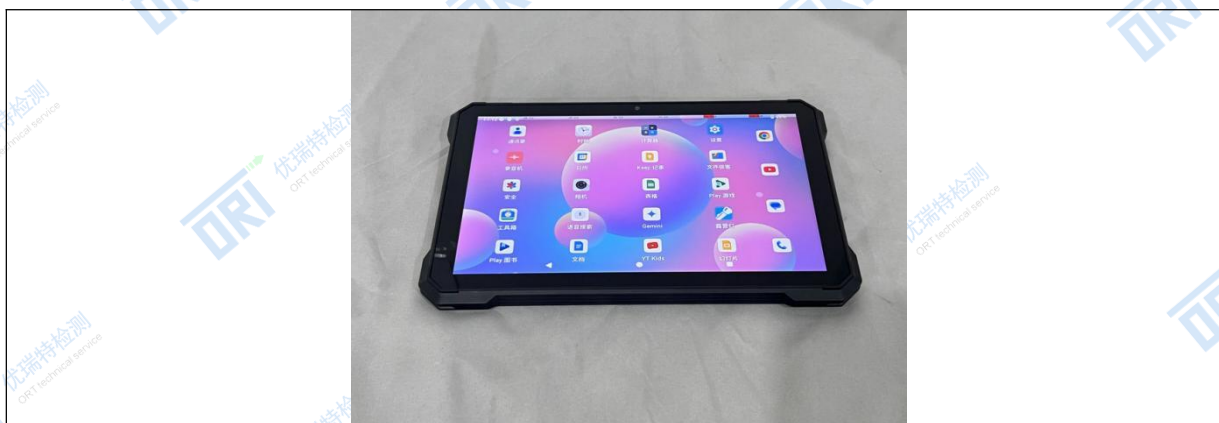
Fig.83 Power on inspection before test

Fig.85 Power on inspection before test

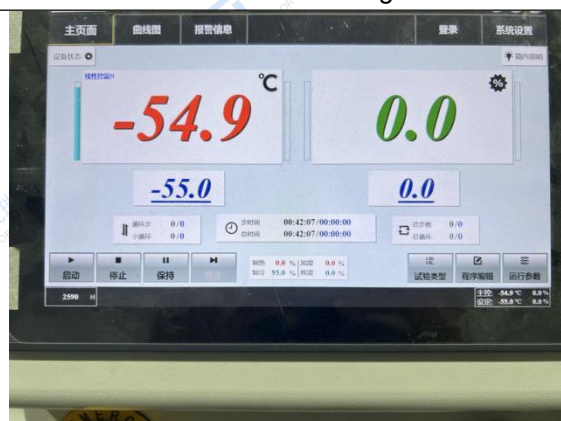
| Shock Test Parameter | | Temperature Test Parameter |
|---|---|---|
| Pulse Shape: | Half Sine | -55℃, 70℃. |

Fig.86 Temperature: -55°C

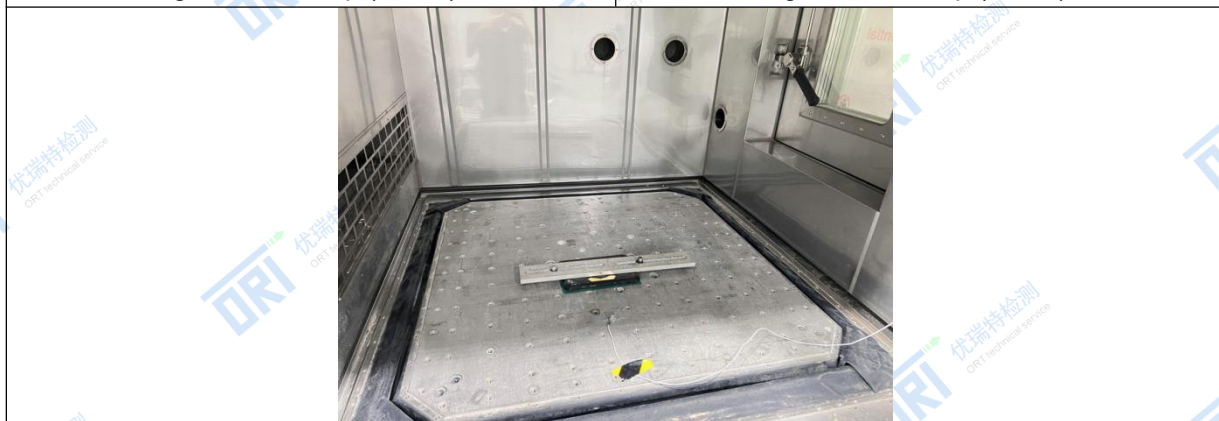
| Shock Test Parameter | | Temperature Test Parameter |
|---|---|---|
| Test Orientation: | ±X, ±Y, ±Z axis | |

Fig.88 Test setup (X axis)

Fig.90 Test setup (Z axis)

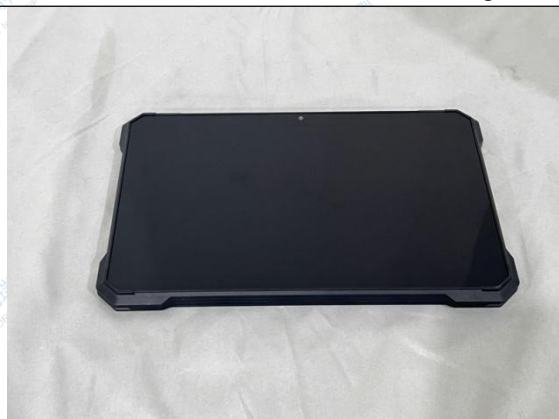
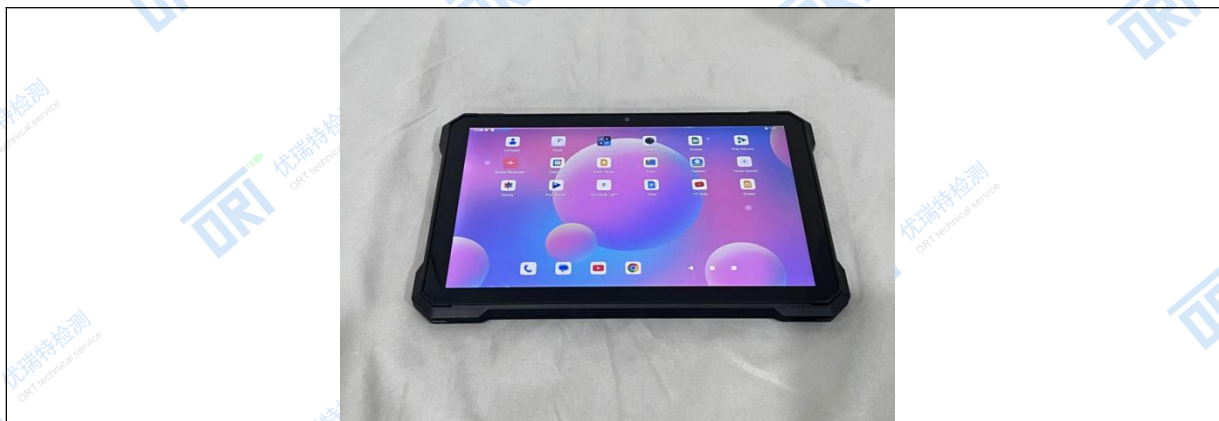
| Sample No. | Inspection after test | Conclusion |
|---|---|---|
| ORT250715112001-SS5/5 | Sample in good appearance and normal function. | Pass |

Fig.93 Appearance inspection after test

Fig.95 Power on inspection after test
