TEST REPORT

Report Number ORT260601112003-R01					
Sample Name:	Smartphone		Applicant:	Shenzhen Huafurui Technology Co., Ltd.	
Model:	KINGKONG ES 5		Address:	Unit 601-03, 6/F, Block A, Building 1, Ganfeng Technology Building, No. 993 Jiaxian Road, Xiangjiaotang Community, Bantian Street, Longgang District, Shenzhen, P.R. China	
Spec:	/		Vendor or Supplier:	Shenzhen Huafurui Technology Co., Ltd.	
Brand:	CUBOT		Address:	As per above address	
Sample Quantity:	5 PCS		Manufacturer:	Shenzhen Huafurui Technology Co., Ltd.	
Specimen Source:	Submitted by applicant		Address:	As per above address	
Received Date:	Jun. 02, 2026	Detection Date:	Jun. 03, 2026 to Jun. 06, 2026	Report Date:	Jun. 08, 2026
Test Standard:	Please refer to the test record on the next page.				
Test Item:	Please refer to the test record on the next page.				
Test Requirements:	Please refer to the test record on the next page.				
Tested By:	Meng WenLong	Date:	Shenzhen ORT Technical Services Co., Ltd. Jun. 08, 2026

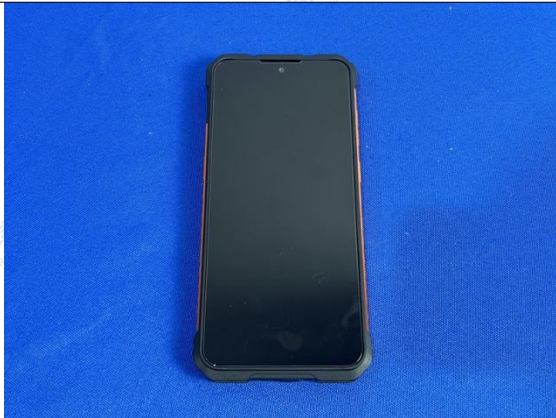
<p>Fig.1: Appearance inspection</p>	<p>Fig.2: Function inspection</p>

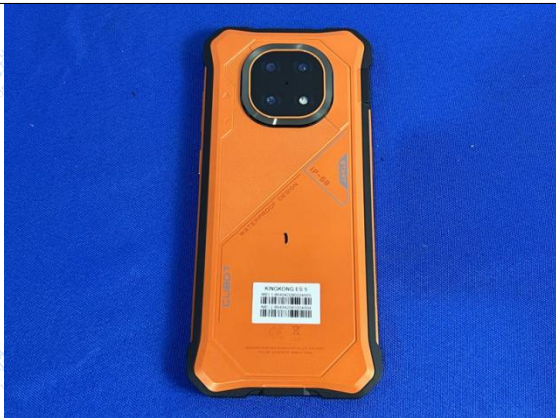
<p>Fig.3: Appearance inspection</p>	<p>Fig.4: Test setup</p>

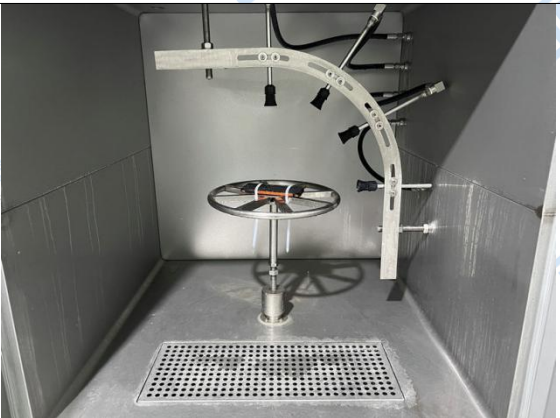
1.4 Test Condition:

1.4.1 Speed: (5±1) r/min.

1.4.2 Spray angles: 0°, 30°, 60°, 90°.

1.4.3 Nozzle distance: 100–150 mm.

1.4.4 Flow rate: 14–16 L/min.

1.4.5 Water temp: (80±5) °C.

1.4.6 Test time: 30 s per position.

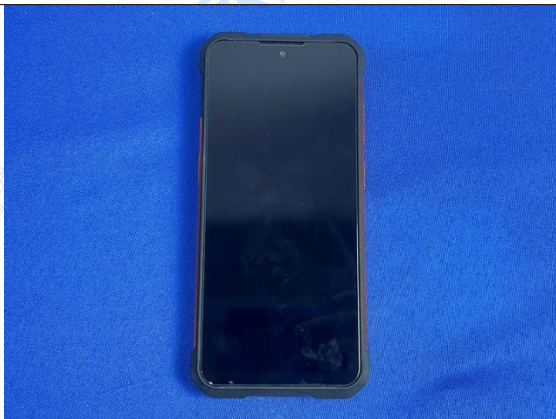
<p>Fig.5: Appearance inspection after test</p>	<p>Fig.6: Function inspection after test</p>

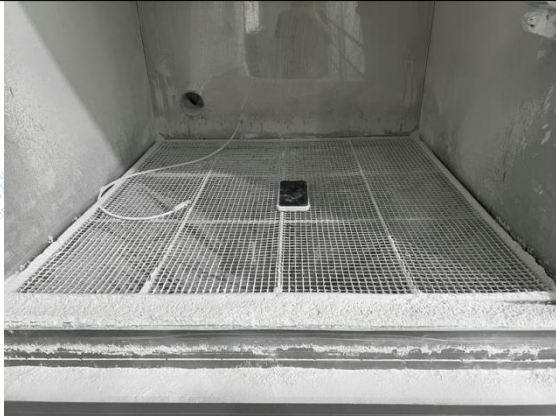
Test dust: Arizona Dust A2.

Dusting method: Air-dust mixture movement for 6 seconds, pause for 15 minutes.

Test duration: 20 cycles.

Fig.14: Test setup

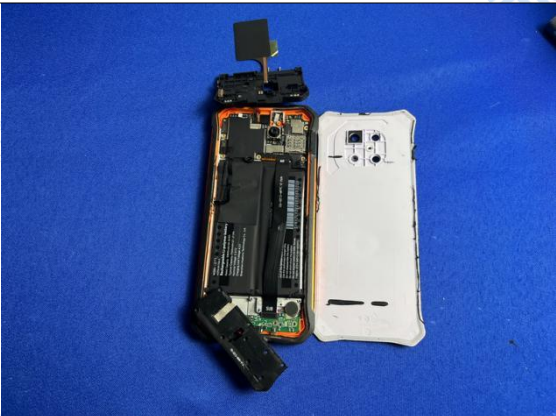
After testing, all samples functioned normally. No dust was detected inside upon disassembly inspection.

Fig.18: Disassembly Inspection after test

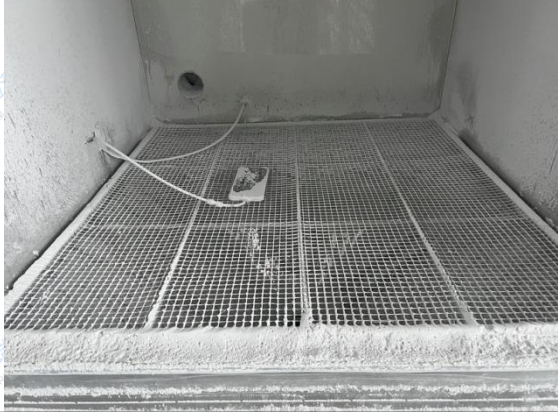
3.4.2 Degree of prevention against solid foreign particles: During the test, talcum powder was used at a concentration of 2 kg/m³ and tested for 8 hours.

3.4.3 The test specimen housing is placed within the testing chamber, where internal pressure is maintained below atmospheric pressure using a vacuum pump. The air volume is 80 times the volume of the sample chamber, with a pumping rate of 40 times the housing volume per hour; the test duration is 2 hours.

Fig.25: Test setup

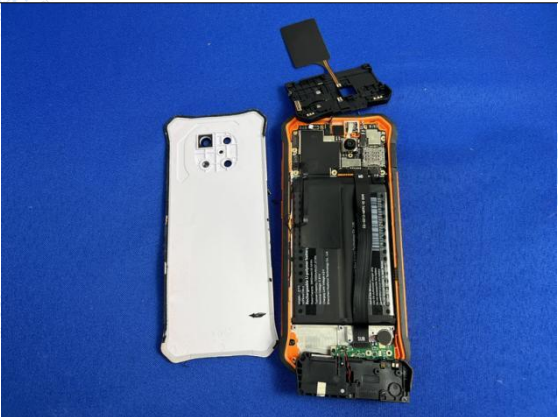
All test samples shall be completed under the specified conditions. The samples shall not be penetrated by the test probe, and there shall be sufficient clearance between the sample and the hazardous component. After testing, the sample functioned properly; upon disassembly and inspection, no dust was found inside.

Fig.29: Disassembly Inspection after test

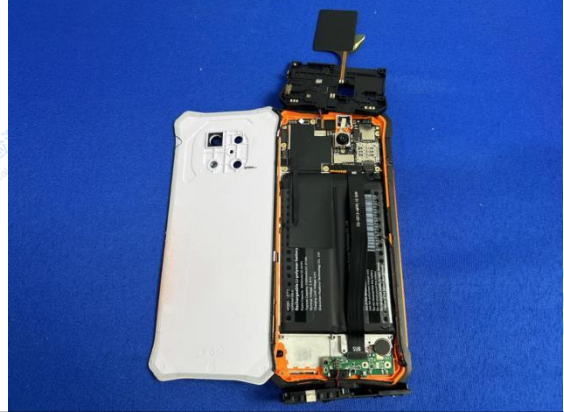
Check the sample function and whether water ingress occurs inside the enclosure.During continuous immersion, if water enters the enclosure, the water volume shall not cause damage to the product.

Fig.37: Disassembly Inspection after test

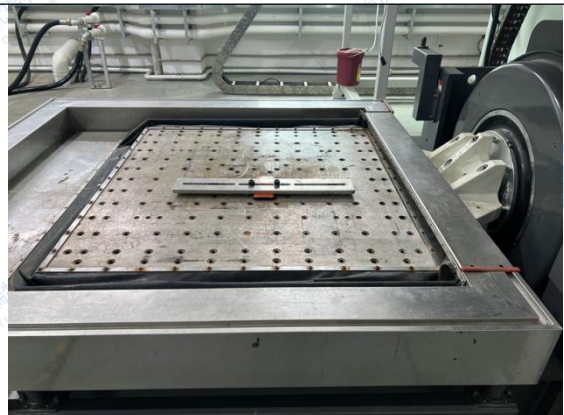
5.4.1 Frequency range: 5 Hz-14 Hz; Displacement: 5.08 mm.

5.4.2 Frequency range: 14 Hz-33 Hz; Acceleration: 2 g.

5.4.3 Frequency range: 33 Hz-52 Hz; Displacement: 0.91 mm.

5.4.4 Frequency range: 52 Hz-500 Hz; Acceleration: 5 g.

5.4.5 Test axes: X, Y, Z. Test duration: 2 h per axis.

Fig.41: Test setup:X

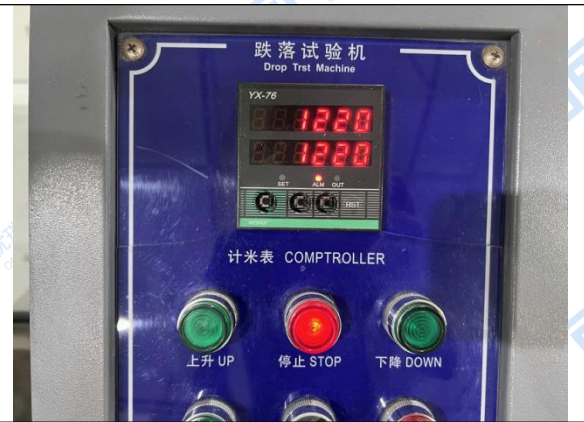
6.4.1 Drop height: 122 cm.

Fig.53: Test setup height

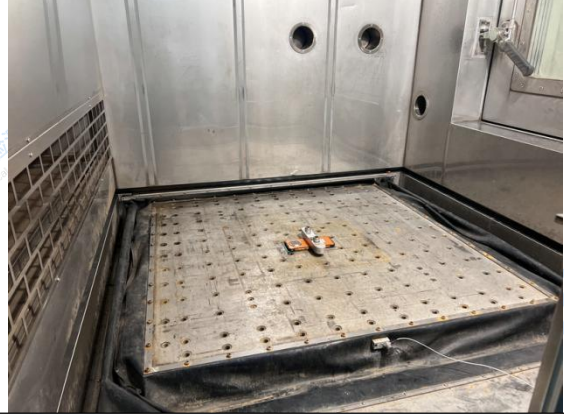
7.4.1 Pulse waveform: Half-sine wave.

7.4.2 Peak acceleration: 30 g.

7.4.3 Pulse duration: 6 ms.

7.4.4 Test axes: +X, +Y, +Z, -X, -Y, -Z.

Fig.86: Test setup:±X

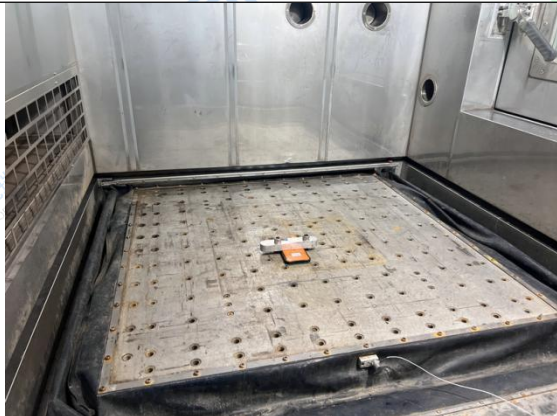
Fig.87: Test setup:±Y

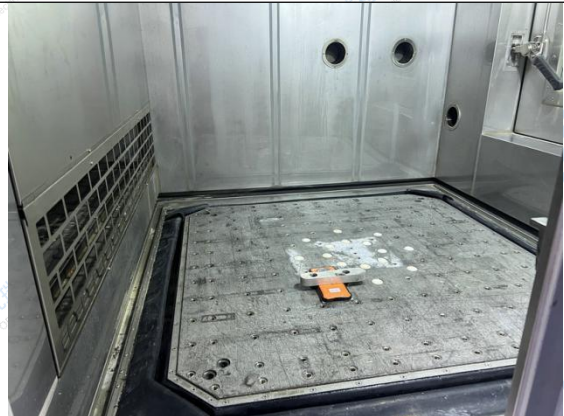
Fig.88: Test setup:±Z
